CUMBERLAND COMMUNITY SCHOOL  
OBAN CLOSE, LONDON, E13

## PROJECT CASE STUDY

# Cumberland Community School Flat Roof Refurbishment & Leak Solution

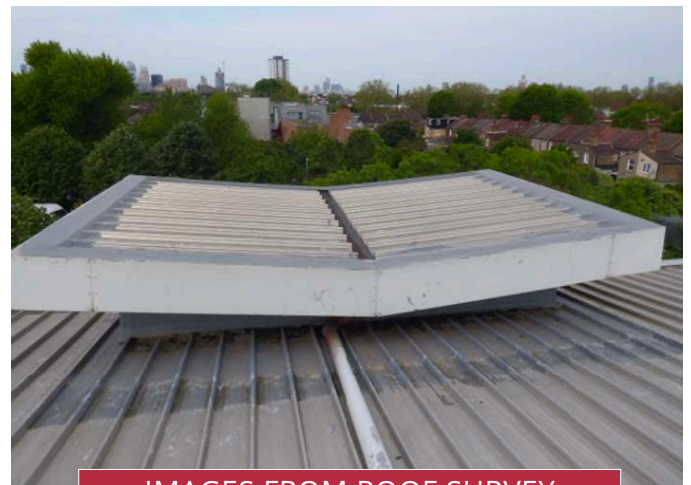
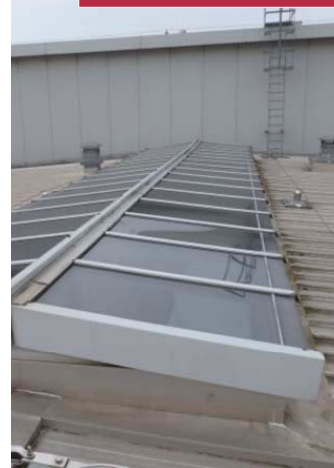
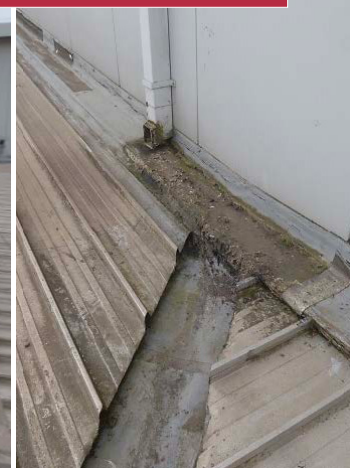
IMAGES FROM ROOF SURVEY

The existing roof system was a Metrac Speed Deck Standing Seam System featuring a secret fix method of installation using non-exposed clips and fixings. Following TCRC's comprehensive roof condition survey, it was established that the most troublesome leaks were occurring through the two top hat roof areas of the main school building. Upon closer inspection, it was clear that many aspects of the roof had not been detailed correctly, thus exposing the structure to the elements and driving rain. It was the same situation elsewhere on the building, with several other roof leaks being caused by poor workmanship and a lack of attention to detail.

Option two was to redesign certain elements of the two top hat roof areas, fill in all the ridges and eaves and then correctly design and install a new liquid system to all areas of the main roof. The client ultimately selected the second option, with the liquid roofing overlay successfully installed by specialist contractors RTL Group. This was supplied with a comprehensive guarantee covering both materials and workmanship.
